From the Frame Up

Tech Tips:

PRODUCT ALERT EL918 Turn Signal Relay - 8 Post

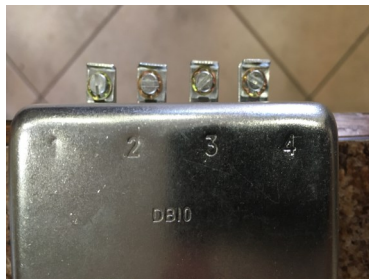
Problem: The short was located at the 8 Post Relay.

Background: In order for the 8 Post Relay to work, it must be grounded. This is accomplished by fastening the box direct to body sheet metal which provides the ground. The metal cover itself is grounded due to it being fastened to the box base plate. Of the 8 posts, 6 are insulated for the circuitry to work. (terminal #1,2,3,5,6, & 7)

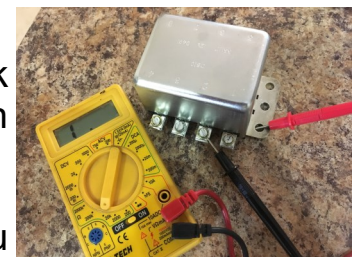
Discovery: There is a very close tolerance between the 6 insulated posts and the box cover. 3 of the 6 posts were found to be in contact with the box cover **after** the flag connectors were installed onto the box. If you look directly down on the box you can see the closeness of the terminals to the box cover.

Testing: To test, after your wiring is connected, simply check for the lack of continuity between terminal and box base with an ohm meter. This should be an open circuit.

Correction: If there is a problem, you should be able to bend the terminal away from the box cover to give clearance. Or modify your flag connector.
