From the Frame Up, LLC

Tech Tips:

AC121 – OIL CAN BRACKET INSTALLATION

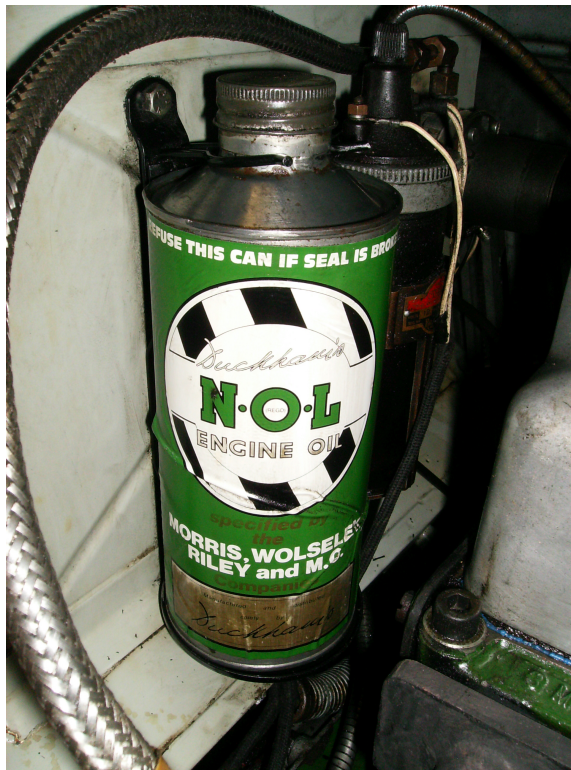
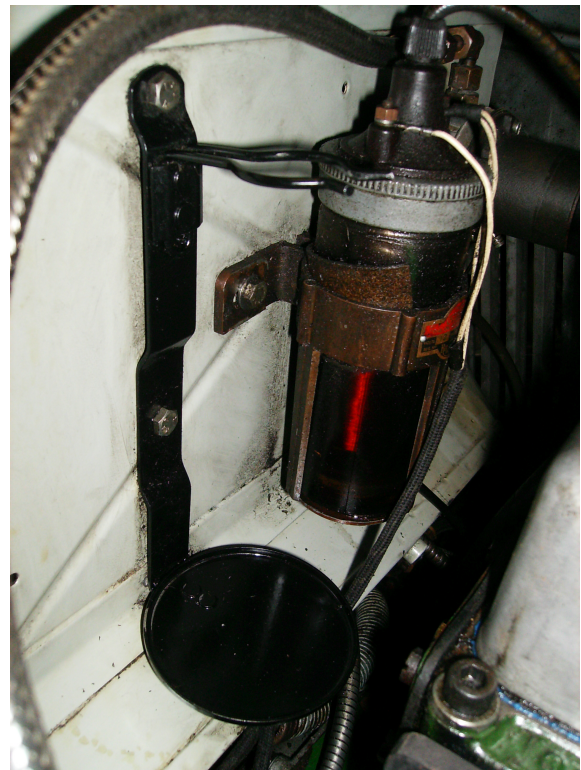
Below are photos of the oil can and bracket. Additionally, a template is provided on the next page to assist in sighting the proper location of the bracket. This template was provided by the Whitworth Shop in Ohio.

Although the oil can and bracket are listed as an accessory, they were actually factory installed original items. Overall, the oil can and bracket are proper for most all but not every TC.

The very early TC's did not have the oil bracket. The first reported sighting is on TC0488, so it appears that the first 1-200 cars may have not had this item. Approximately Sept 1948, the oil can was eliminated on those cars slated for export to include the EXU's. However, this is not absolute for all exports except the EXU. The EXU could not install the bracket due to conflicting EXU equipment (wire harness for the horns)
