From the Frame Up

Tech Tips:

ST228 Tompkins Steering Kit - Product Safety Alert ST229 Tompkins Cover - Rebuild Kit

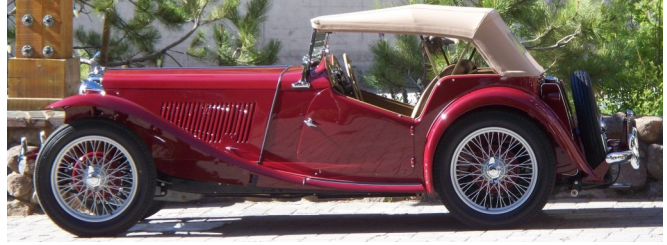
The well-known Tompkins Steering Kit was designed to accurately adjust the MG TABC steering box and thus improve the driving experience. However, it has been discovered that this kit (as provided by suppliers) is actually the primary cause of poor steering control on our early T-Series cars. The problem lies with the size of the needle bearing and thrust washers.

Principle: The Tompkins kit provides adjustment of the end float on the top of the sector shaft. This keeps the steering peg engaged properly in the steering cam (eliminates play). The friction of the adjust screw on the sector shaft is effectively eliminated by adding a needle bearing sandwiched by 2 thrust washers.

Problem: The thrust washers fit nicely into the Tompkins cover. But, due to variations in the casting of the steering box itself, the thrust washer has been found to sit on top of the box and not within the box itself and on top of the sector shaft. This means that when you tighten the adjust screw you cannot get full adjustment because the thrust washer is hung up on the top of the steering box body. In the photos you can see the distinct difference in the wall thickness of the Tompkins cover and the steering box itself. You will also note that the thrust washer has ample clearance from the cover wall but when centered on the sector shaft there is no clearance to the box wall.

Solution: The singular solution is to install a set of thrust washers with needle bearing that is a smaller diameter to clear the steering box wall. FTFU has developed a retrofit kit that is now available and corrects the problem. FTFU item #ST229, replaces the adjust screw, thrust washers, and needle bearing.

- * Jack up the front end of the car and turn the Tompkins adjust screw down to full tight. Then try to turn the steering wheel.
- * If the wheel will not turn then your Tompkins kit is ok. Simply back off adjust screw slightly and tighten locknut. If you still have steering play, troubleshoot other components such as tie rod ends, kingpins, loose bolts, suspension, etc.
- * If the steering wheel turns with the adjust screw full tight, then you probably have the thrust washer hanging up on the top of the box. Remove and replace the Tompkins internals with FTFU ST229. If needed, email: order@fromtheframeup.com
