From the Frame Up, LLC

Tech Tips:

EL960 - EARLY TC WIRING DIAGRAM Errors & Corrections

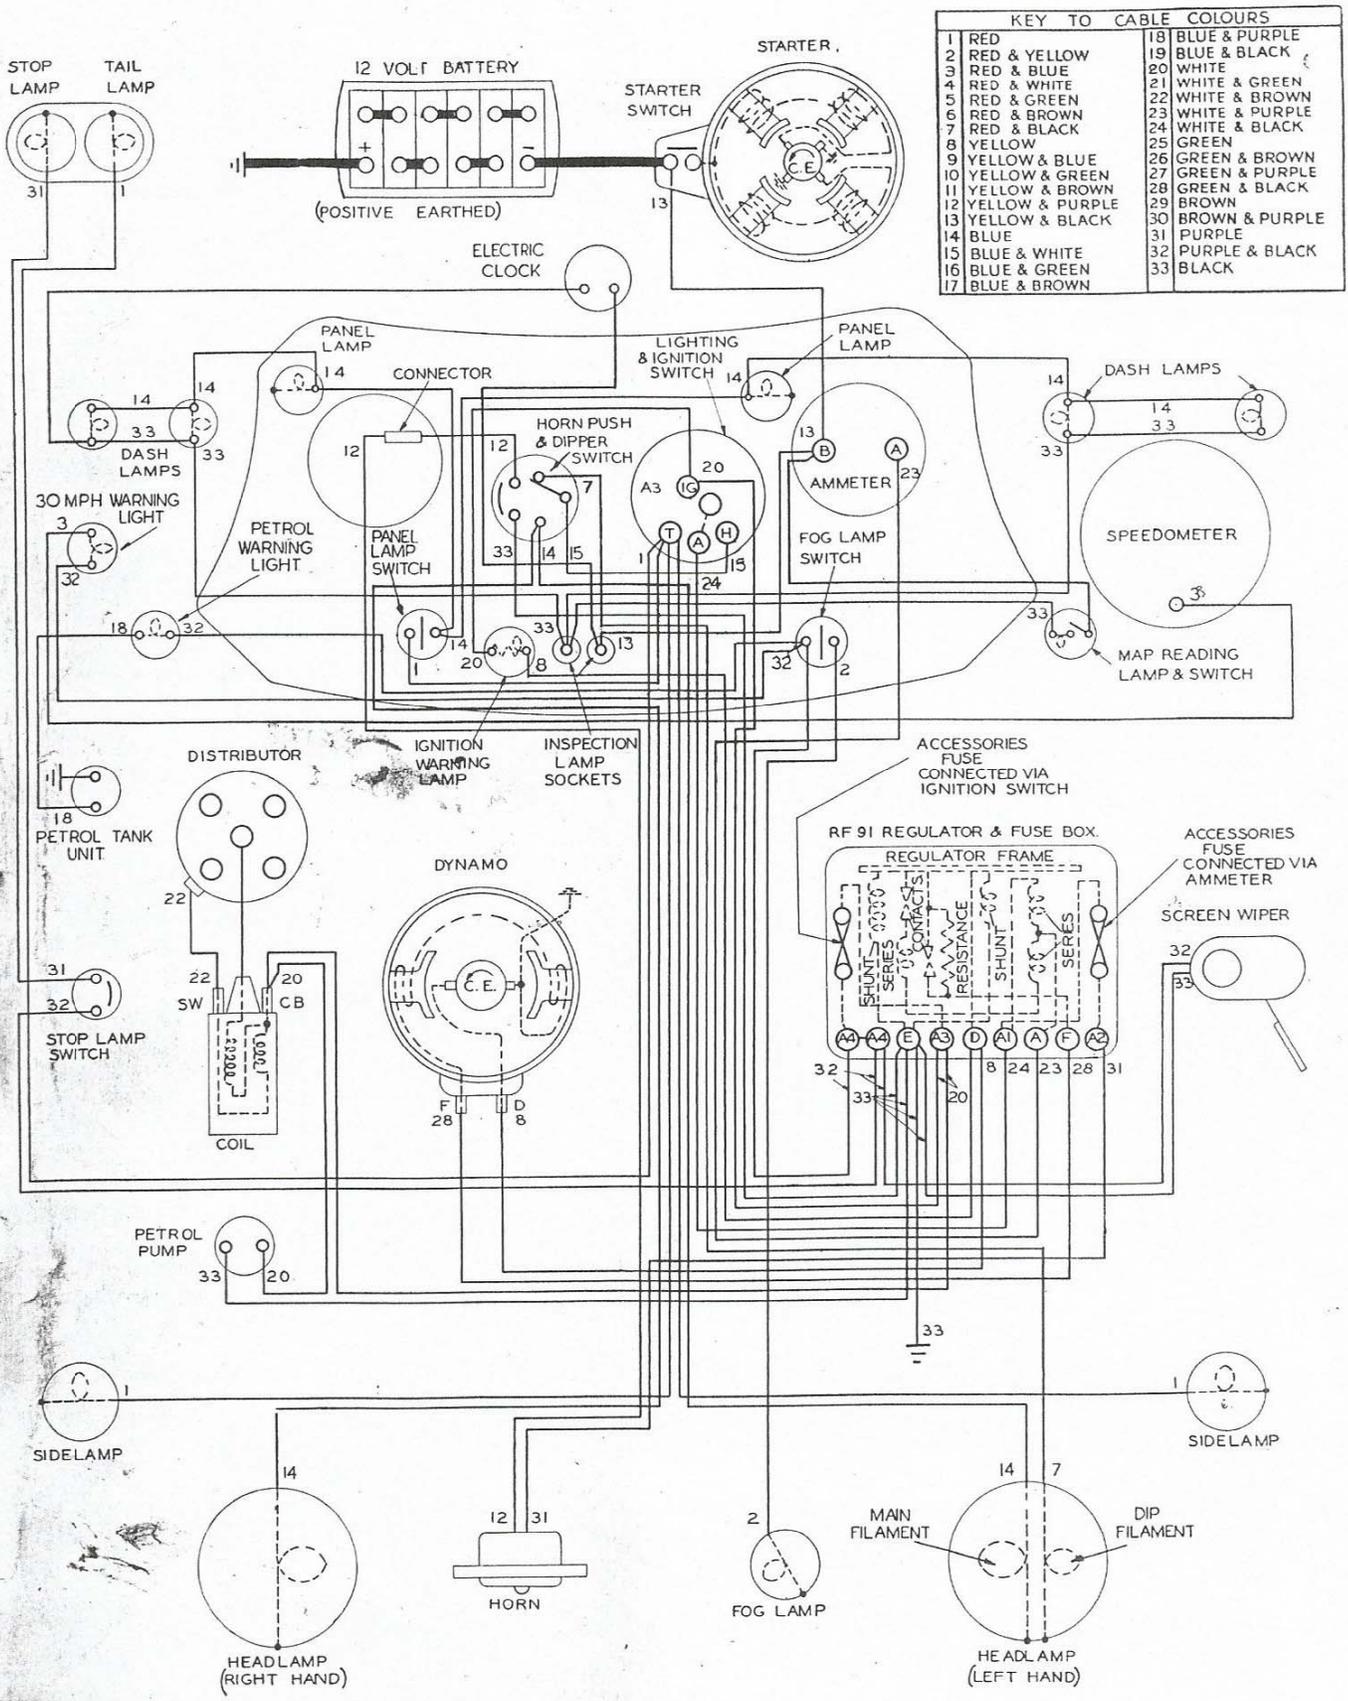
Illustration No. 50.—Diagram of electrical wiring system.

On the next 2 pages you will find copies of the original diagrams taken from the May 1946 printing of the Brown Book for both the Home and Export models. Differences noted should be:

- Color codes are proper and should be used in lieu of later printings of wiring diagrams.
- Regulator shown is RF91. Note: In August 1947, there was a production change where the RF91 regulator was changed to the RF95.
- The 30 light wiring is included in the early 1945/8 Home Model diagram which is not the case with the later Home Model diagrams.

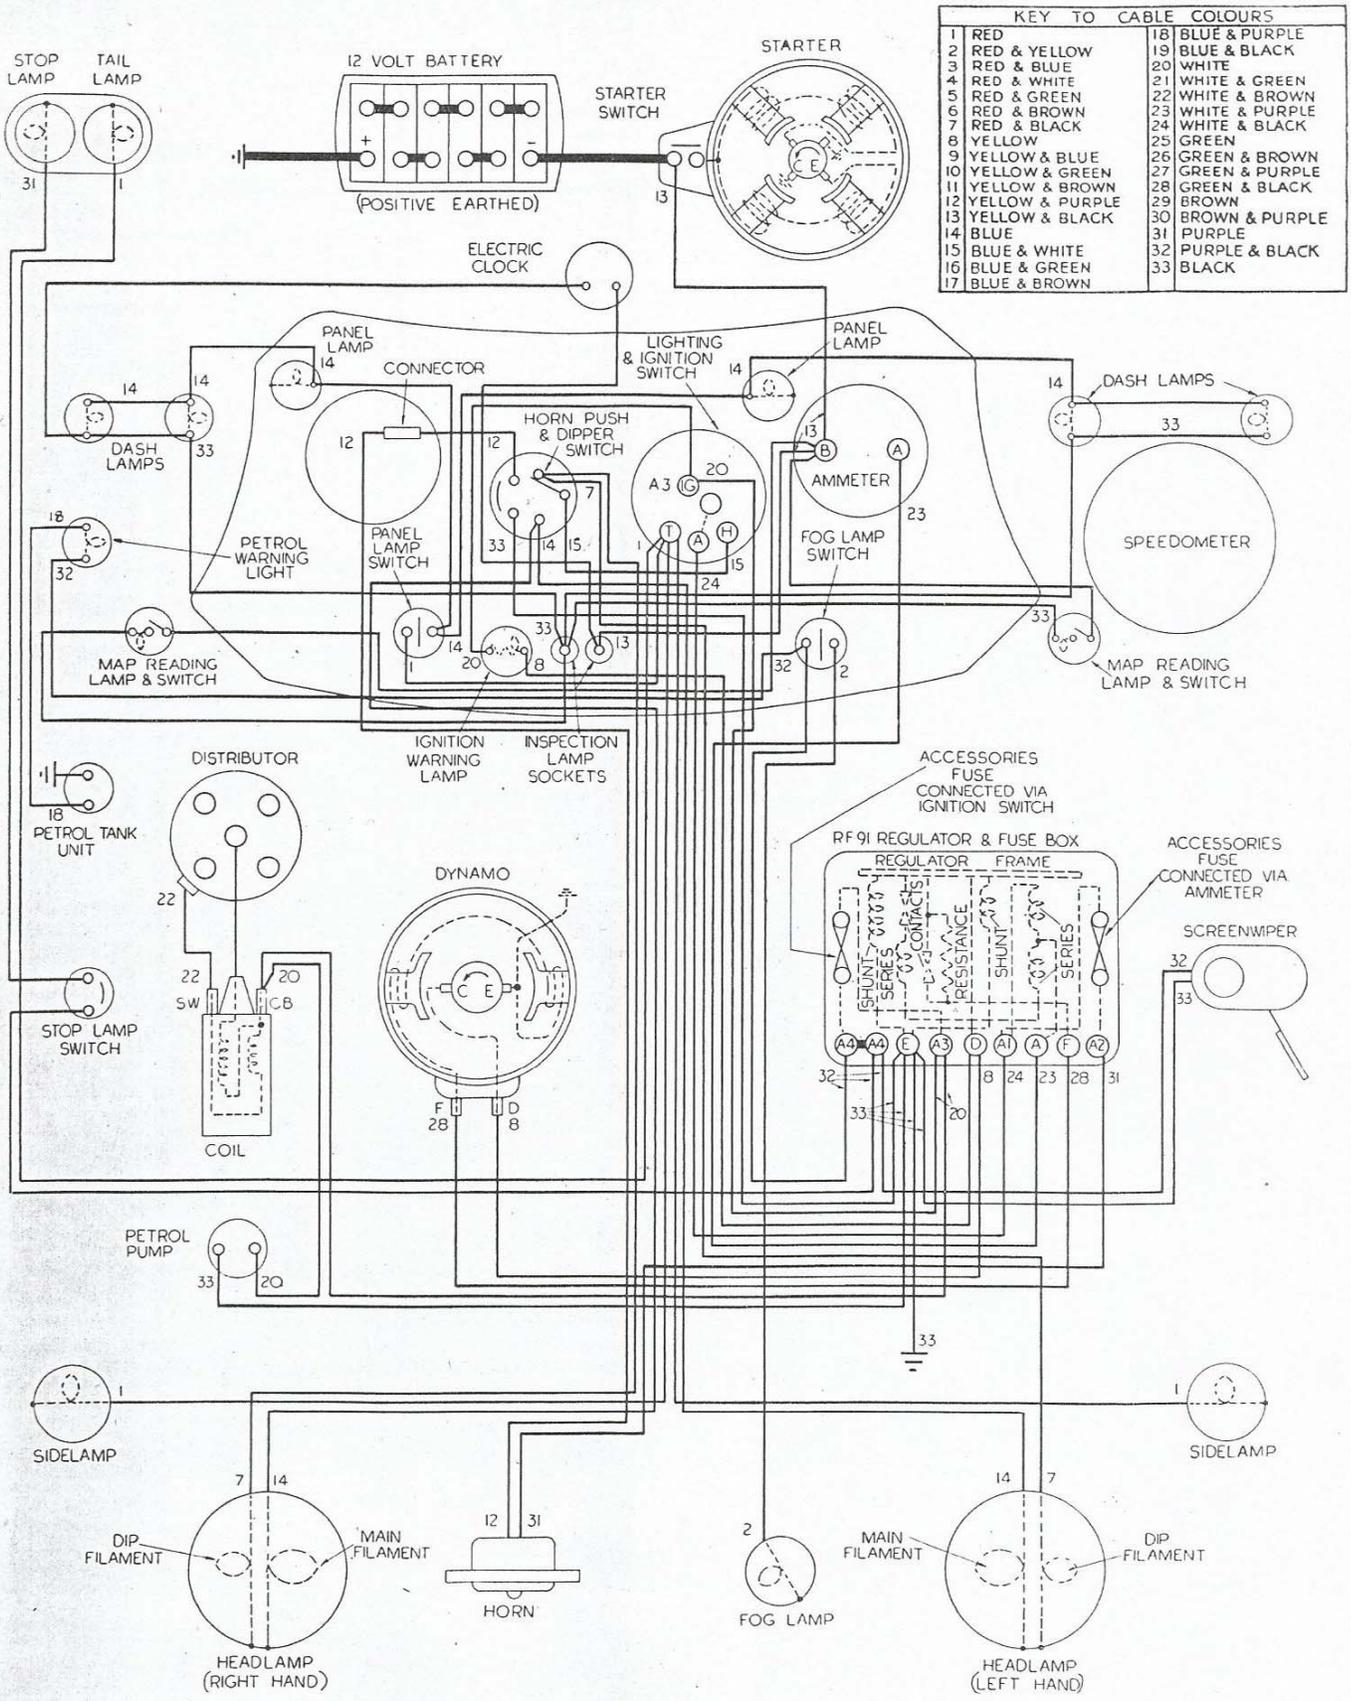
Illustration No. 53.—Electrical circuit for Export cars.
